Examination of Failed Components From District of Columbia Incinerator No. 5

Failure Analysis Report

Prepared for
Construction and Repair Division
Department of Environmental Services
Government of the District of Columbia 20019

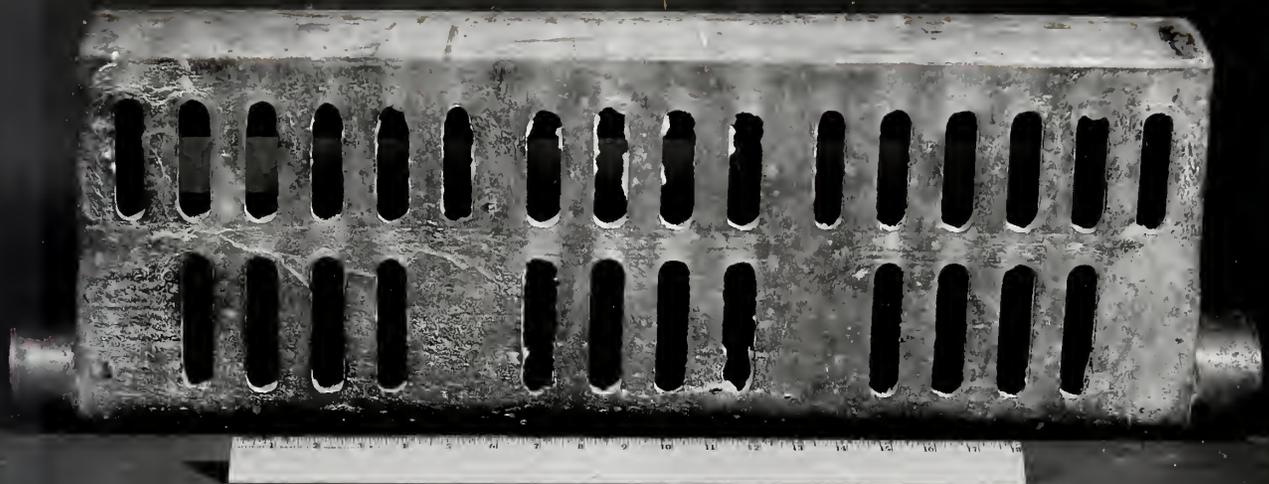
a. New grate.

Figure 1. Bottom view of grates as received. Smallest scale division equals $1/16$ inch.

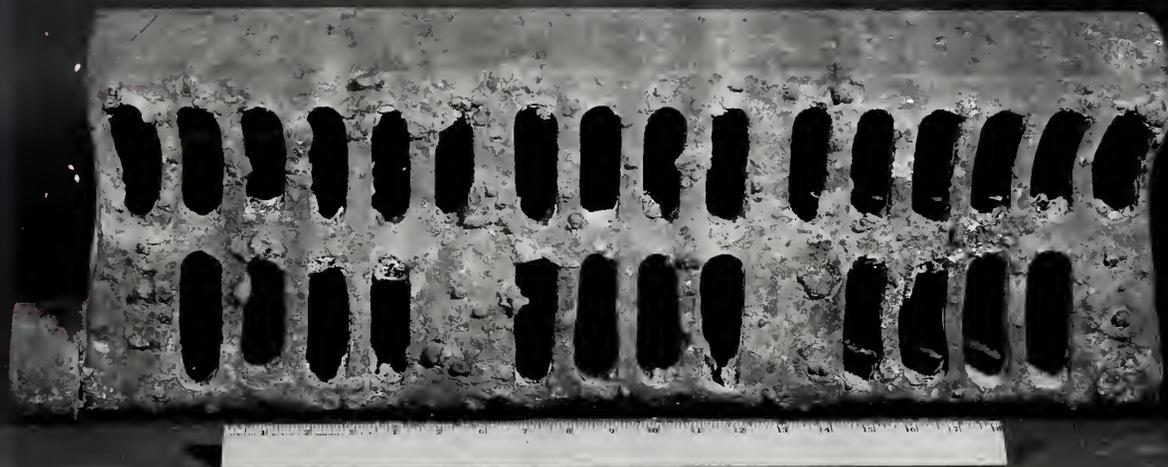
b. Used grate.

The used grate was covered with a fairly heavy scale at and near the bottom and on most of the inside surface. The new grate had an apparently superficial layer of rust on most of the surface except for the area which had been painted. There was considerable distortion in the bottom "grille" work and along both sides of the used grate (figures 1b and 5) as compared with the new grate (figure 1a). There were various bits of material attached to the grille of the used grate (figure 5). Some of this material could be easily removed, but most of it was firmly attached to the grate, and some of the material was in globular form appearing as though it had melted and resolidified on the grate bottom.

One of the trunnion pins from the used grate had apparently fractured, and it and the companion trunnion were separated from the grate.

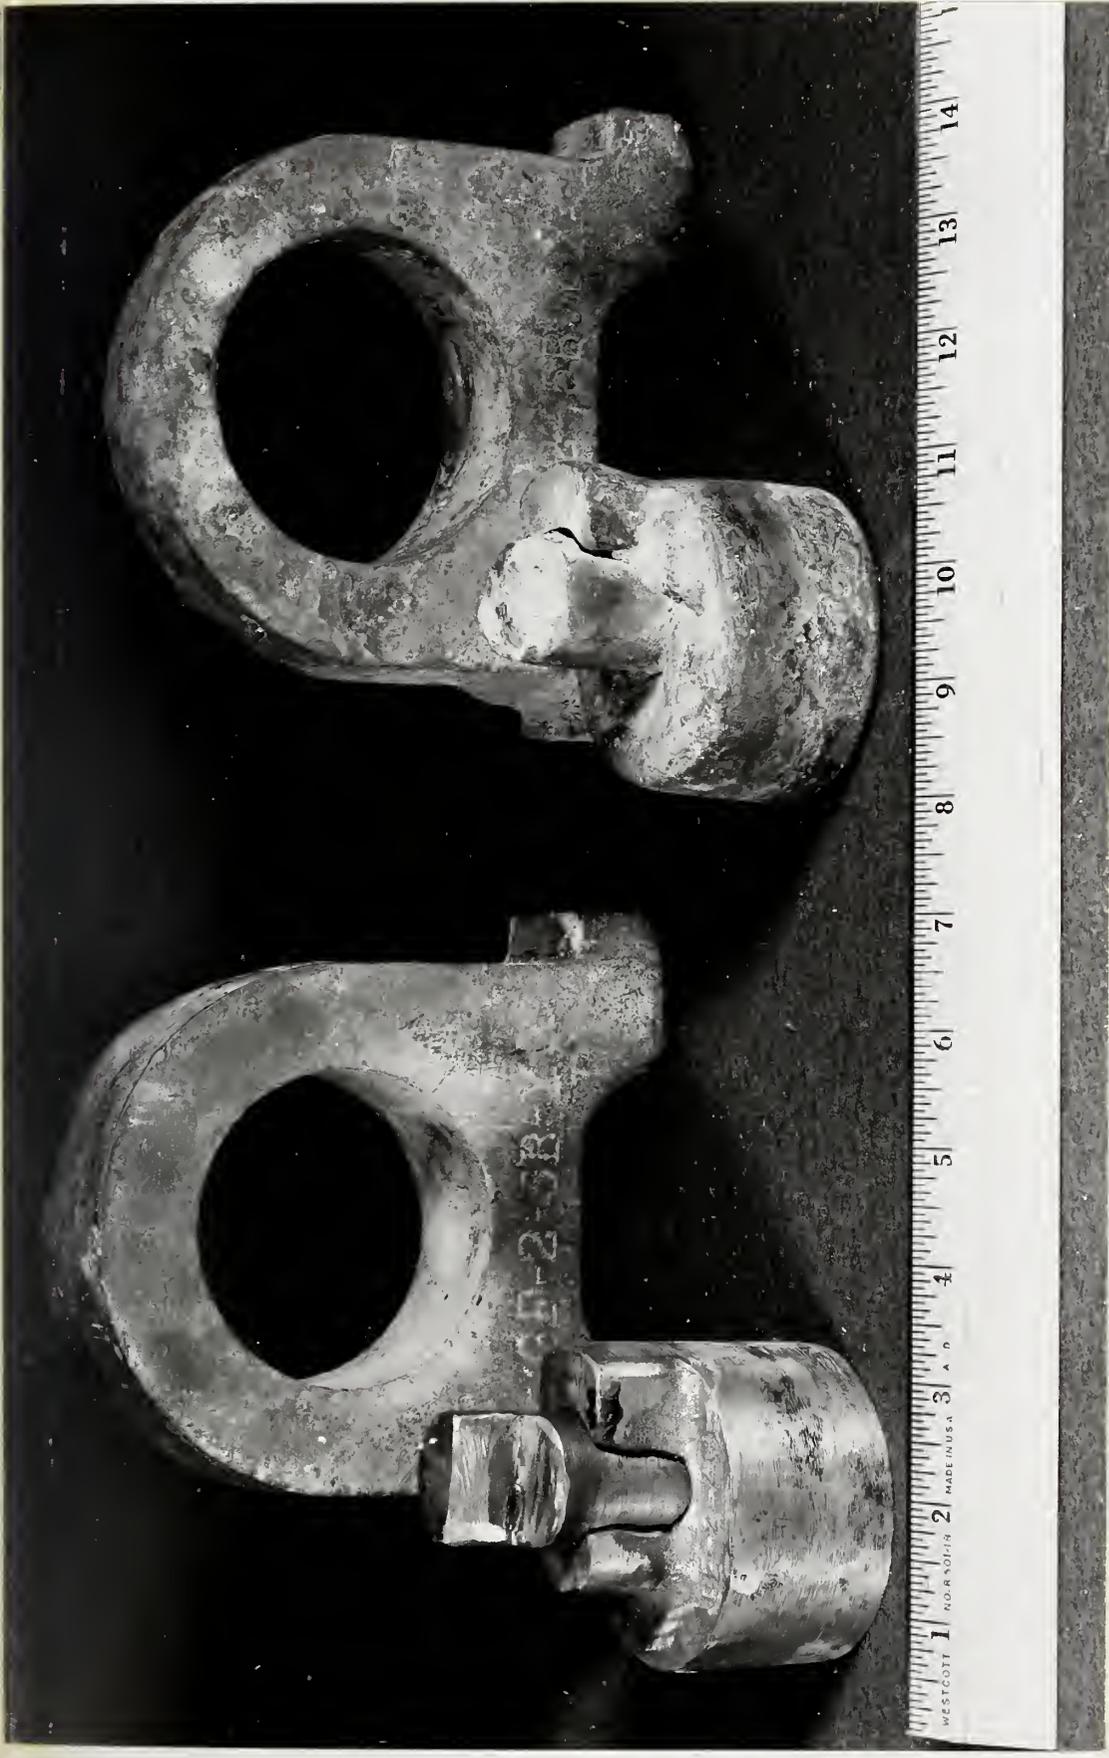
In addition to the three trunnions attached to the grates (figures 1a and 1b), there were two used and one new trunnion submitted for examination (figures 2 and 3). The outer surfaces of the two new trunnions attached to the new grate were painted. The new trunnion not attached to a grate was not painted and had a small amount of what appeared to be superficial rust on the surface, but otherwise appeared to be similar to the attached trunnions.

The one trunnion attached to the used grate was covered with scale, and there was a light grey deposit adjacent to the head of the trunnion pin. This trunnion-trunnion pin assembly appeared to be bent relative to the grate. The other trunnion-trunnion pin assembly for this grate was missing, and apparently at least the pin had fractured. Some of the

light grey deposit was also located in the cavity in the used grate where the assembly had been. Both of the used unattached trunnions had fractured. One of them exhibited very little rust and there was still considerable bright metal showing. The appearance of this trunnion compared to the appearance of the other used trunnions indicated that this trunnion may have been in use for a relatively short period of time, or was in an area of the incinerator which was not subjected to the heat of the burning trash. Both the other unattached used trunnion and the attached used trunnion were covered with a fairly heavy scale.

Of the two trunnion pins attached to the new grate, only the heads were visible, and these were painted. The new unattached trunnion pin was not painted and had a small amount of superficial rust. The shaft of the pin was straight. The heads of the two used trunnion pins were covered with scale. The unattached pin had apparently fractured (figure 2) close to the point of attachment to the grate, and the shaft was bent. The shaft of the attached trunnion pin also appeared to be bent.

One new and one used trunnion socket were submitted for examination (figure 2). The used socket was covered with a heavy scale. The new socket was painted only in places and was covered with a superficial rust where there was no paint. The diameter of the hole of the new socket measured 3.0 inches and that of the used socket measured 3.1 inches. The widths of the tops of the sockets (measured parallel to the center line of the hole) were 0.99 inch for the new one and 0.67 inch for the used one. There was much less difference in the widths at the bottom where the measurements were 0.98 inch for the new socket and 0.97 inch for the used socket.

Figure 2. New trunnion, trunnion pin, and trunnion socket as received at left. Used trunnion, trunnion pin, and trunnion socket as received at right. Smallest division of scale equals 1/16 inch.

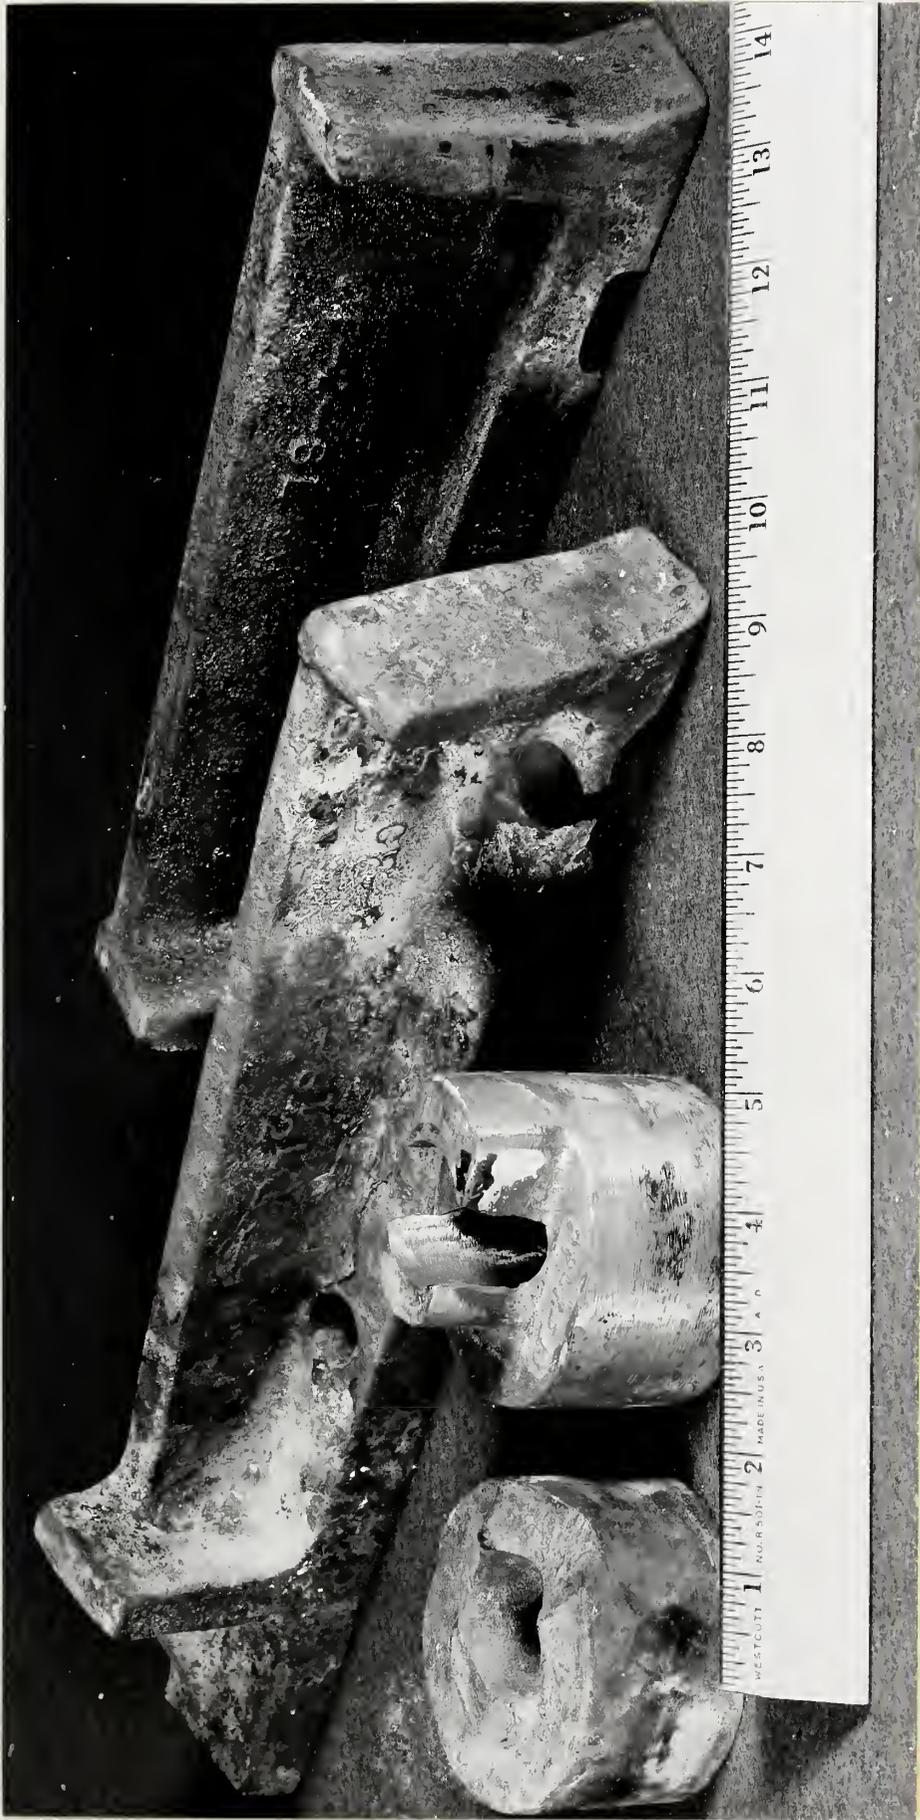
The used "spacer" was covered with a heavy scale and exhibited considerable distortion. The new one was partially covered with paint, and the unpainted areas were covered with a superficial rust. Enough material had been lost from one area of the used "spacer" so that the side of the "spacer" intersected one of the two bolt holes. This can be seen in figure 3.

Figure 3. New "spacer" at right, used "spacer" at top left, and used, fractured trunnion at bottom left as received. The new trunnion shown for comparison is the same one shown at the left in figure 2. Smallest division of scale equals 1/16 inch.

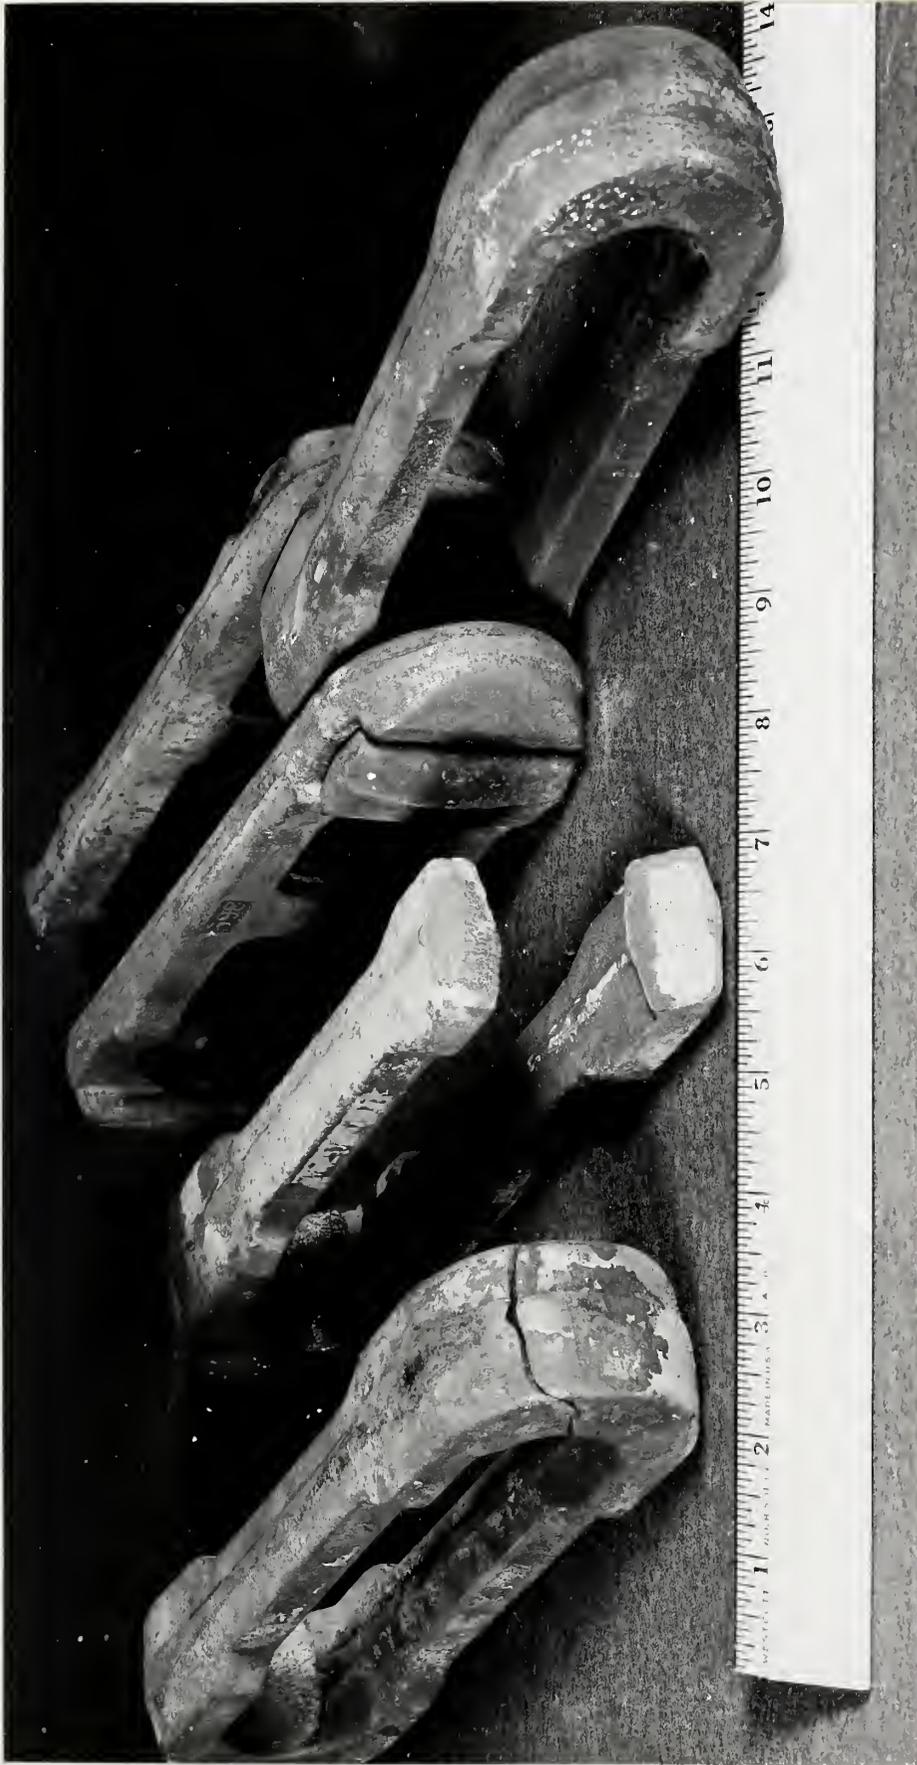
Both of the fractured chain links had patches of a grey, powdery substance on their surfaces. In the areas not covered with this substance, the link surfaces were covered with scale. One of the fractured links had separated into at least two pieces, and only the piece shown in figure 4 (link in the center of the photograph) was submitted. One of the two fracture surfaces shown in the figure was about 75% covered with what appeared to be the same grey substance found on the link surfaces. The intact link was covered with scale and there was no evidence of the grey substance visible to the eye. There was no apparent distortion in any of the links, but in the fractured link which had not separated, the fracture faces had separated slightly.

Figure 4. Two used, fractured chain links at left and center, and one used, intact chain link attached to a two-piece connecting unit as received. Smallest division of scale equals 1/16 inch.

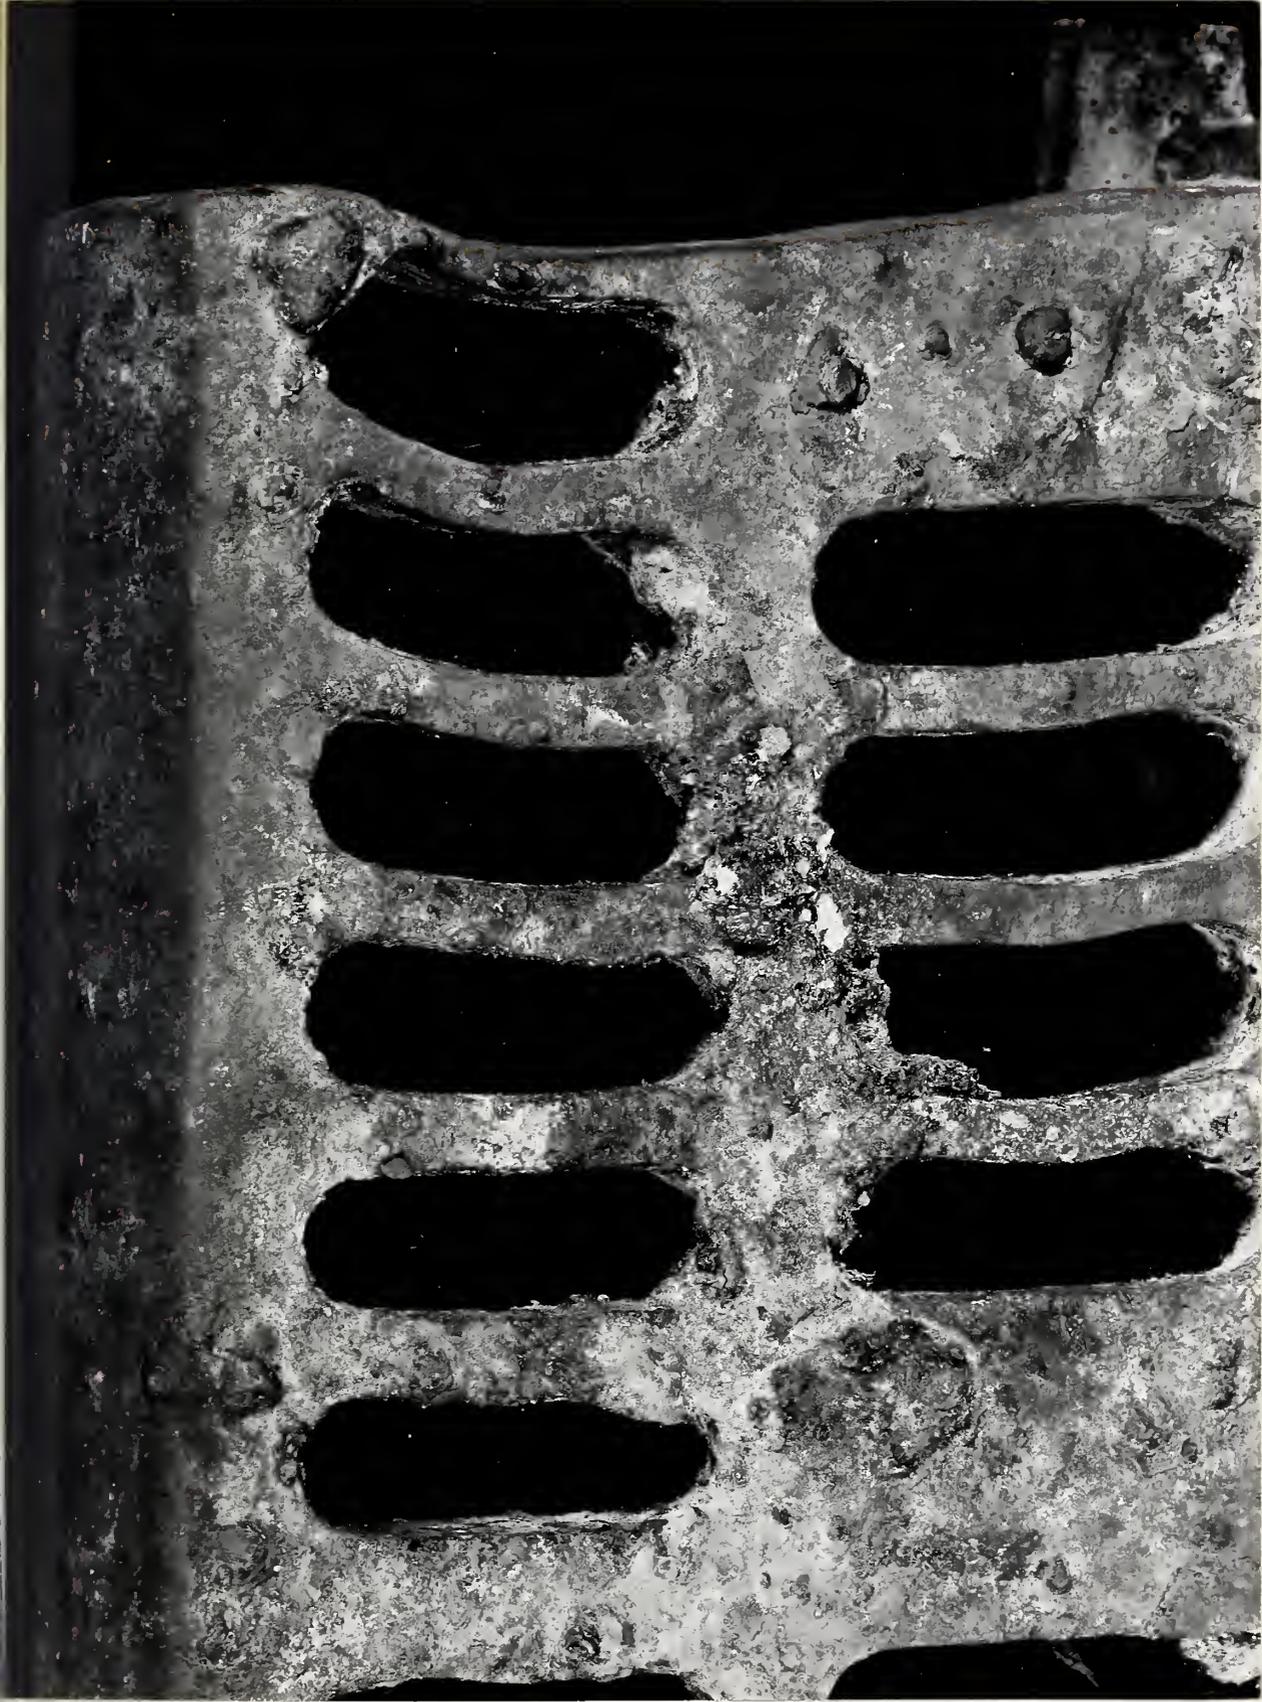
Figure 5. Part of the bottom "grille" work of the used grate showing attached material and distortion. X 2/3

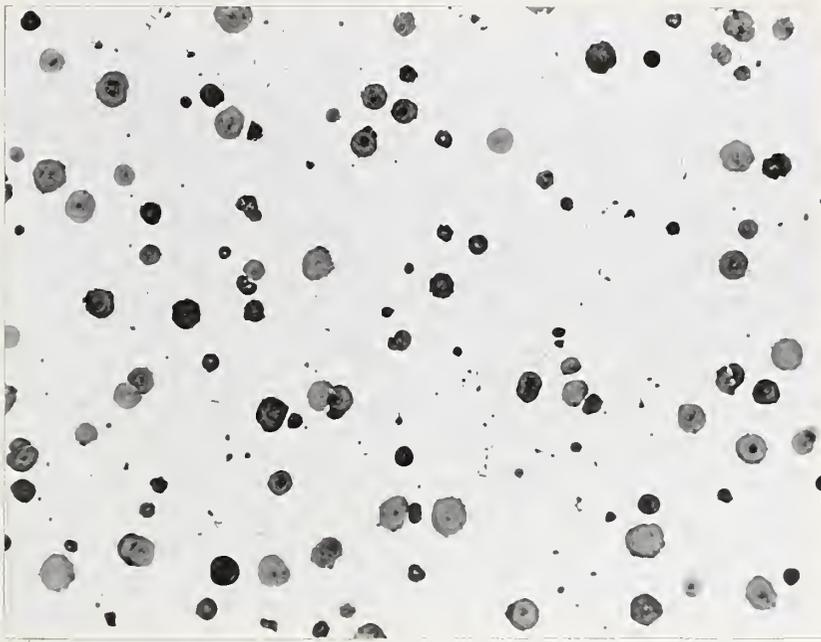
The microstructure of cross sections taken from both the top and the bottom of the new grate and the top of the used grate were essentially the same. A typical unetched microstructure representative of these areas is shown in figure 6. The cross section shown was taken from the top of the used grate. The dark, round areas are graphite nodules. The material appears to be relatively free of inclusions and no porosity is evident. An etched microstructure representative of this material (figure 7, cross section through bottom of new grate) shows the graphite nodules in a matrix consisting of essentially all pearlite. This appears to be an as-cast structure.

Figure 6. Unetched microstructure of cross section through top of the used grate. The dark round areas are graphite nodules. X 100

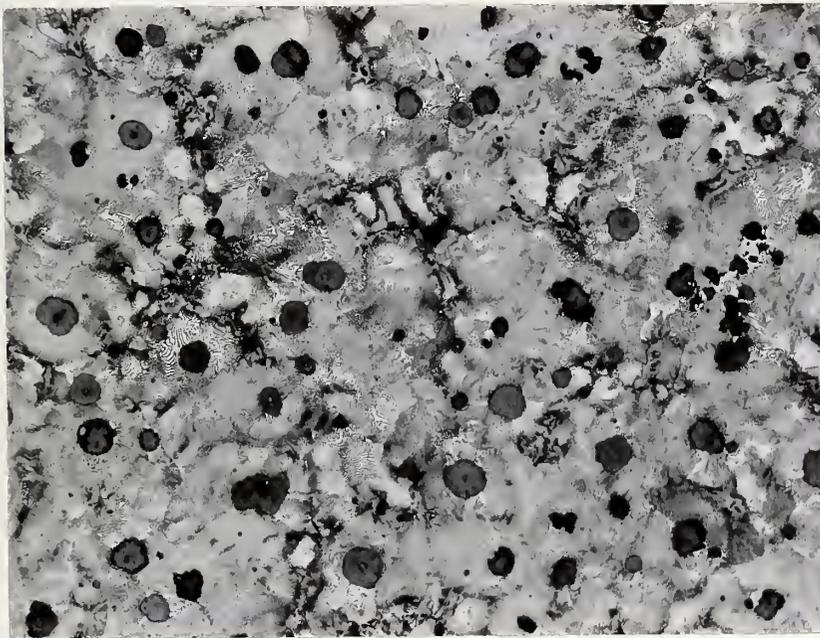
Figure 7. Etched microstructure of cross section through the bottom of the new grate. The dark round areas are graphite nodules. The matrix is essentially all pearlite. Etch: 3% nital. X 100

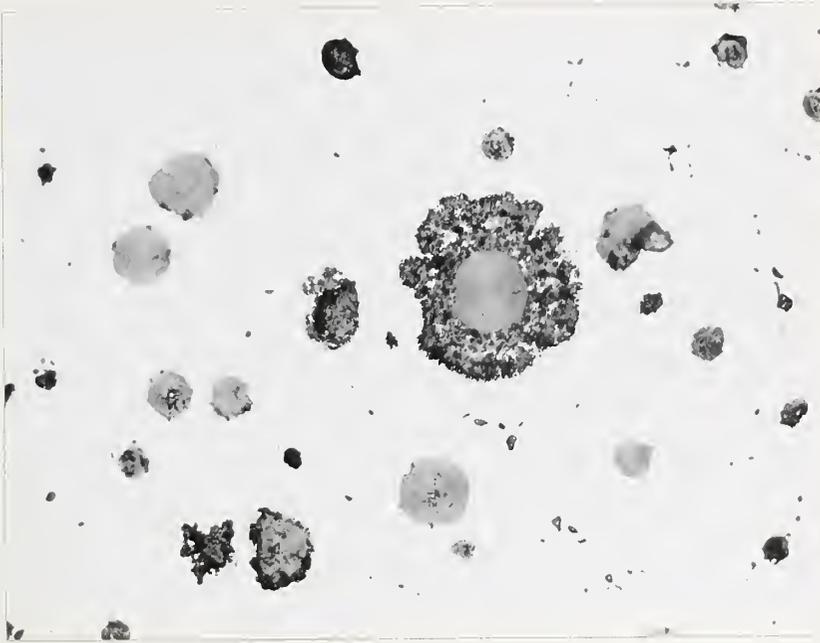
A different microstructure is exhibited by the material from the bottom of the used grate. An unetched microstructure of a cross section through the bottom of the used grate is shown in figure 8 (at a higher magnification than figures 6 and 7). There is secondary graphite surrounding some of the graphite nodules. An etched microstructure from this cross section (figure 9) shows that the matrix is mostly ferrite with a small amount of spheroidized cementite instead of pearlite. The presence of these constituents indicates that the material was probably heated to temperatures in the range of 1200 to 1300° F for an appreciable period of time.

The microstructure of the material from the bottom of the used grate appears similar to that expected from an extended annealing heat treatment between about 1200 and 1350° F. The extent of the decomposition of the cementite indicates that the material was held at a temperature of approximately 1300° F for many hours total. The decrease in hardness and tensile properties, and the changes in dimension and microstructure of the material from the bottom of the used grate could all have been caused by the grate bottom being subjected to excessive temperatures for this material. The distortion in the bottom members could have been produced by thermal cycling to temperatures near and/or above the eutectoid temperature (about 1330° F).

Figure 8. Unetched microstructure of cross section through used grate bottom showing graphite nodules and secondary graphite. X 200

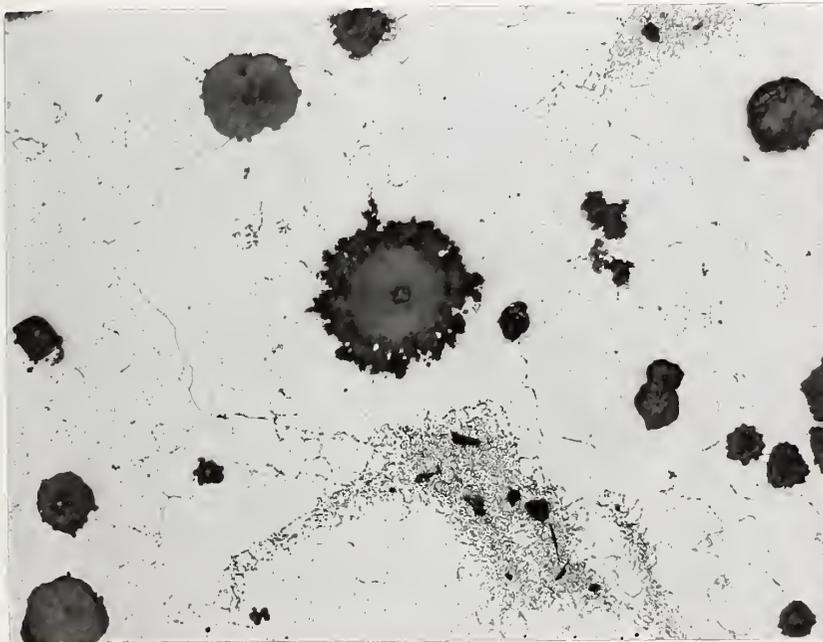
Figure 9. Etched microstructure of cross section through used grate bottom showing graphite nodules, some of which are surrounded by secondary graphite. Matrix is nearly all ferrite with a small amount of spheroidized cementite. Etch: 3% nital. X 200

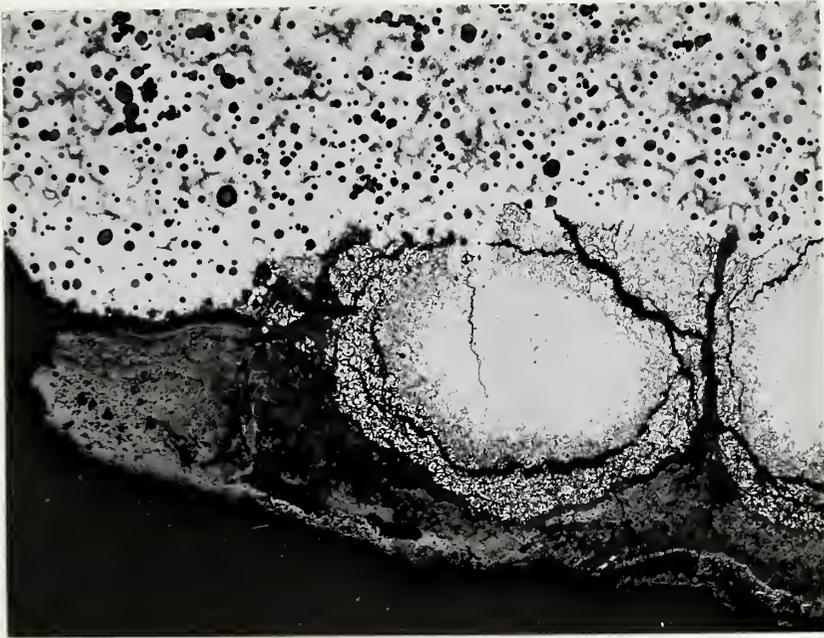
An etched microstructure of a cross section through one of the globules (no. 2 in Table 3) where it was attached to the grate bottom is shown in figure 10. The material appears to have fused to the grate bottom.

Figure 10. Etched microstructure of cross section through globule no. 2 and the adjacent portion of the grate bottom to which it was attached. Etch: 3% nital. X 40

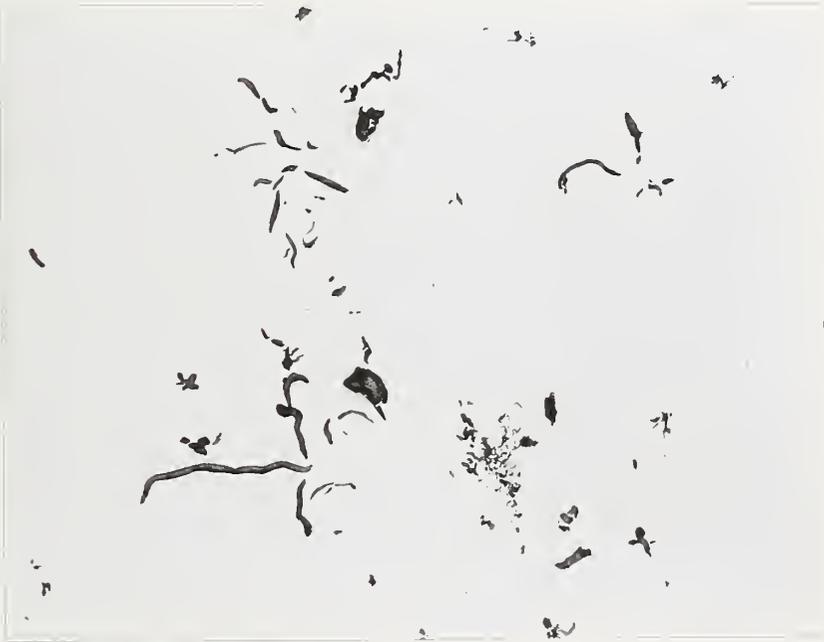
The unetched microstructures of cross sections from the new and the used trunnions are shown in figures 11 and 12, respectively. The dark areas appear to be graphite, or, in some places, cavities where graphite was pulled out during metallographic preparation. These figures may not represent typical concentrations of the graphite, but they do illustrate the relative sizes and shapes of the particles.

Figure 11. Unetched microstructure of cross section through the new trunnion. Most of the dark areas are graphite. X 100

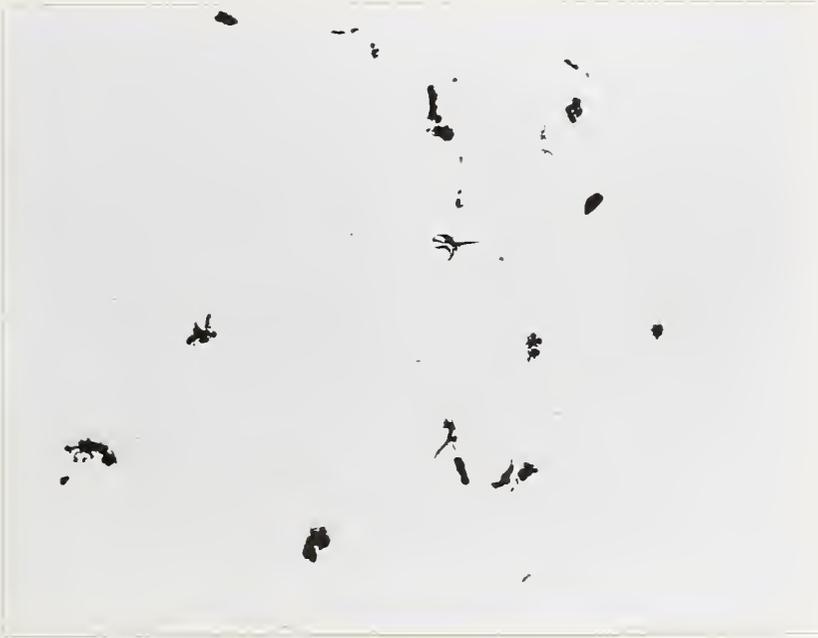
Figure 12. Unetched microstructure of cross section through the used trunnion. Most of the dark areas are graphite. X 100

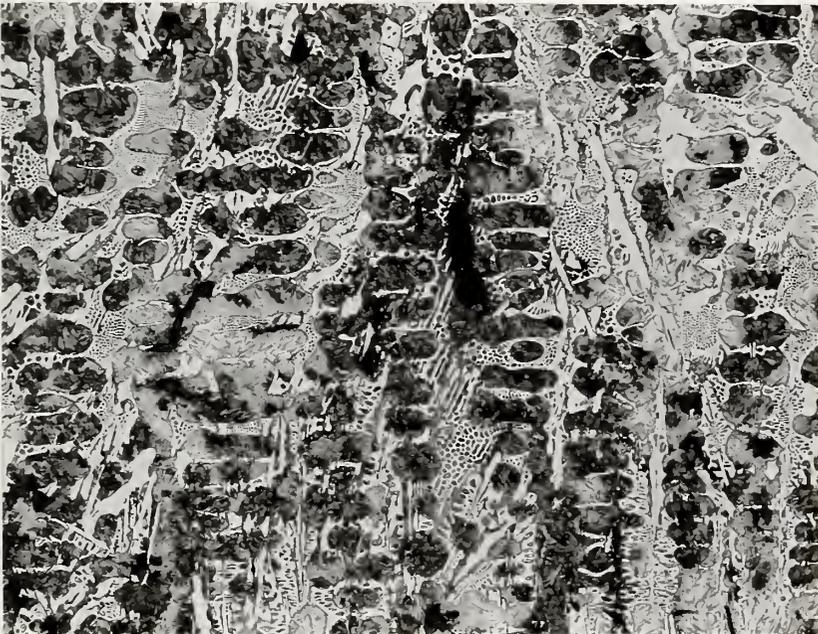
Etched microstructures of cross sections through the new and used trunnions are shown in figures 13 and 14, respectively. A dendritic structure of prior austenite is exhibited in both cases. In figure 13, the microstructure consists of cementite (white area), martensite (grey area), and what appears to be unresolved pearlite (dark area, could not be resolved up to X 800). The microstructure of the used trunnion (figure 14) has essentially an as-cast appearance and consists of cementite and tempered martensite.

Figure 13. Etched microstructure of cross section through the new trunnion. Microstructure is dendritic and consists of cementite (white), martensite (grey) and what appears to be unresolved pearlite (dark). Etch: 3% nital. X 100

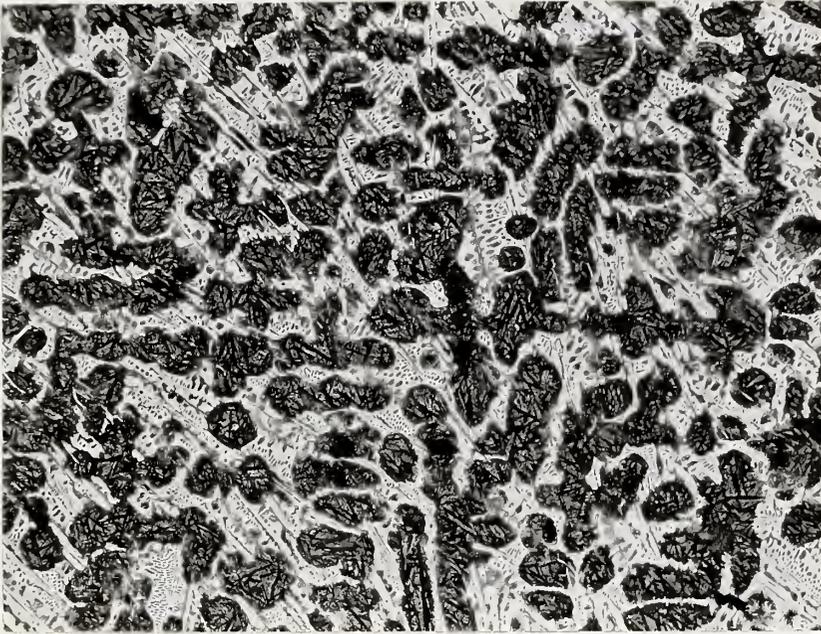
There were, however, significant differences between the microstructures of the new and used trunnions. The presence of tempered martensite and the lack of pearlite in the used trunnion indicates that this trunnion was subjected to temperatures greater than 1330° F, and then cooled rapidly. This change in microstructure is consistent with the changes in the microstructure of the used grate bottom. In both cases, the changes could have been brought about by excessive temperatures.

Figure 14. Etched microstructure of cross section through used trunnion. Microstructure is dendritic and consists of cementite (white) and tempered martensite (dark). Etch: 3% nital. X 100

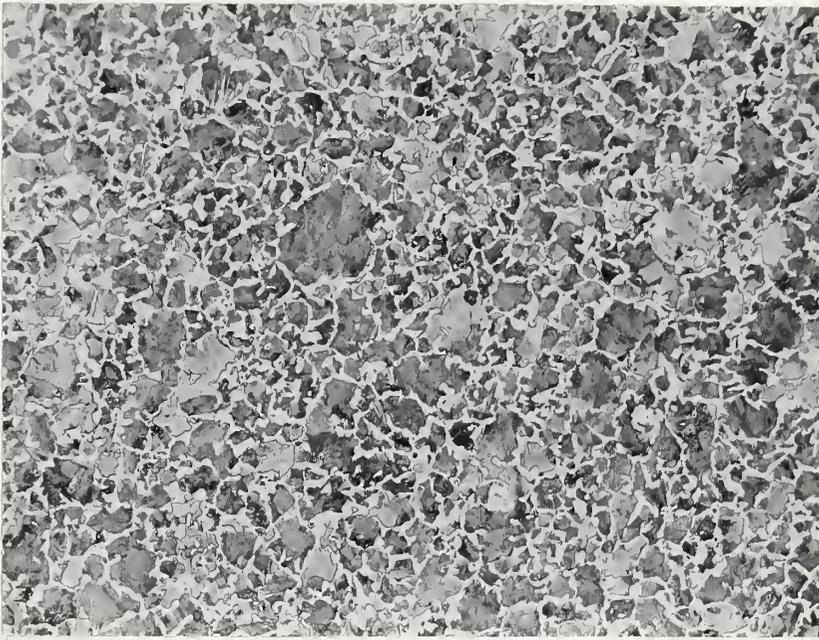
An etched microstructure of a cross section through the new trunnion pin is shown in figure 16. It appears to be a normalized structure consisting of pearlite in a pro-eutectoid ferrite network.

Figure 16. Etched microstructure of cross section through new trunnion pin. Microstructure is "normalized" and consists of pearlite in a pro-eutectoid ferrite matrix. Etch: 3% nital. X 100

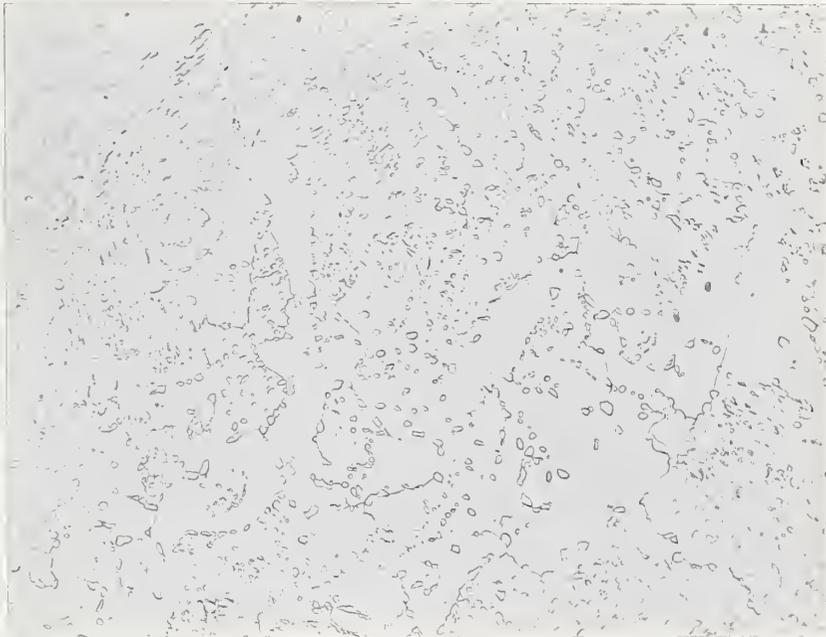
The microstructure of the used trunnion pin (figure 17) consists of spheroidized carbides (probably mostly iron carbide, Fe_3C) in a ferrite matrix. The spheroidized microstructure can be formed from the normalized structure by holding the material at an elevated temperature for a long period of time.

Assuming that the used trunnion pins before service were essentially the same as the new trunnion pin, a significant change in microstructure took place in the used trunnion pin. Both the decrease in hardness and the changes in microstructure could have been caused by subjecting the trunnion pins to temperatures considered excessive for this material.

Figure 17. Etched microstructure of cross section through used trunnion pin. Microstructure consists of spheroidized carbides in a ferrite matrix. Etch: 3% nital. X 500

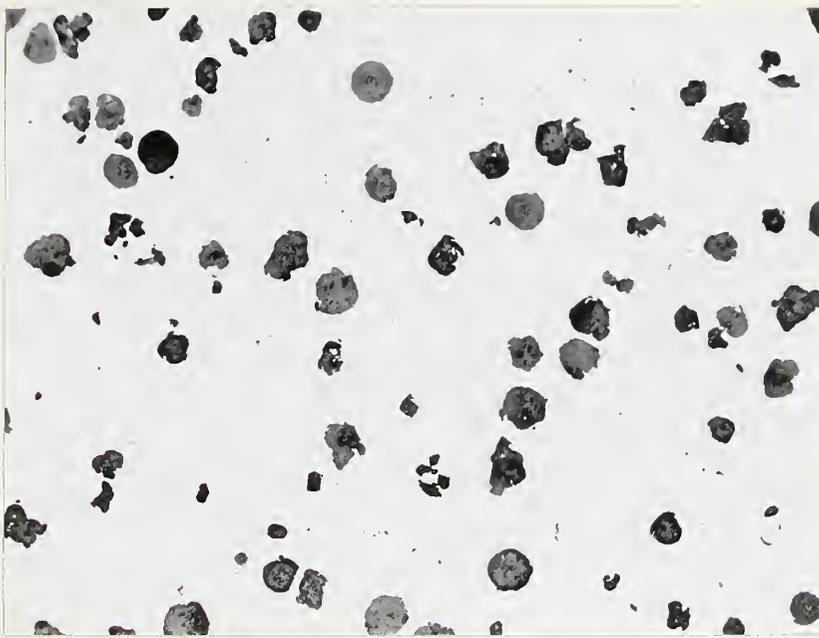
The trunnion sockets were specified to be manufactured from "wear resistant alloyed iron"¹. Material from both the new and the used trunnion sockets appear similar in the unetched condition. A typical unetched microstructure of a cross section through the new trunnion socket is shown in figure 18. The dark, round particles are graphite nodules.

Figure 18. Unetched microstructure of cross section through the new trunnion socket. The dark, round particles are graphite. X 100

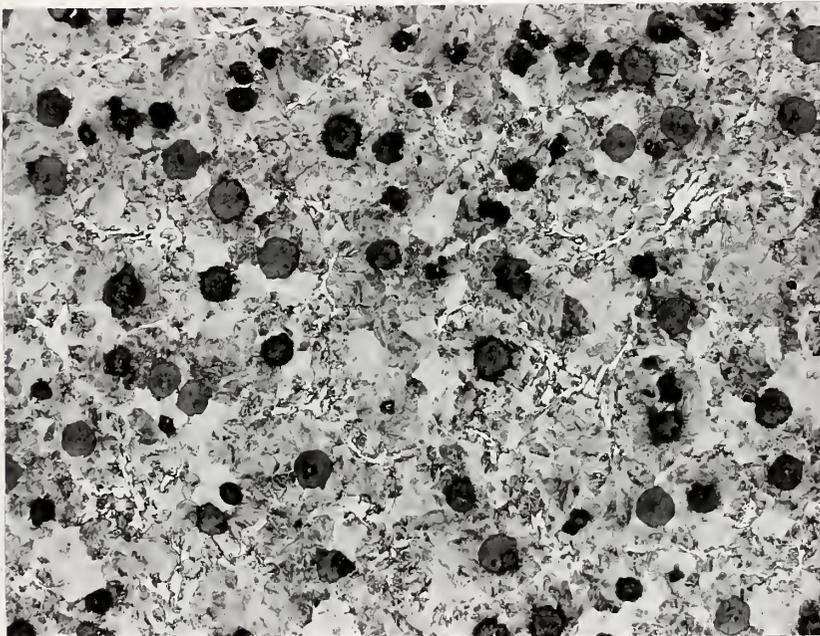
The etched microstructure of a cross section through the new trunnion socket is shown in figure 19. The microstructure consists of graphite nodules in a matrix containing primarily pearlite (grey) with some massive cementite (white).

Figure 19. Etched microstructure of cross section through the new trunnion socket. The microstructure consists of graphite nodules (dark), pearlite (grey), and massive cementite (white). Etch: 3% nital. X 100

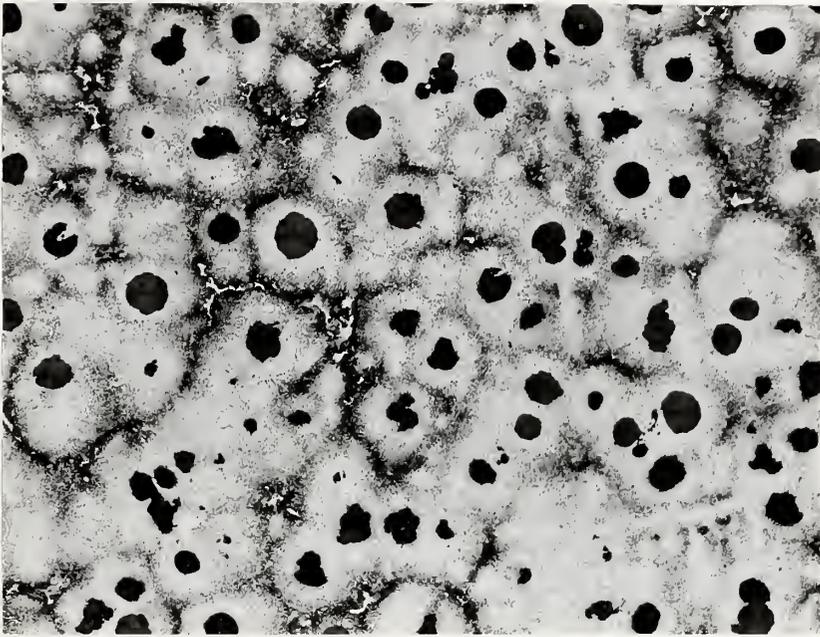
The etched microstructure of a cross section through the used trunnion socket is shown in figure 20. The microstructure here consists of graphite nodules in a matrix of ferrite (white), spheroidized carbides (appearing as small dark dots), and a very small amount of pearlite.

Figure 20. Etched microstructure of cross section through used trunnion socket. Microstructure consists of graphite nodules in a matrix of ferrite (white), spheroidized carbides (appearing as small dark dots), and a small amount of pearlite. Etch: 3% nital. X 100

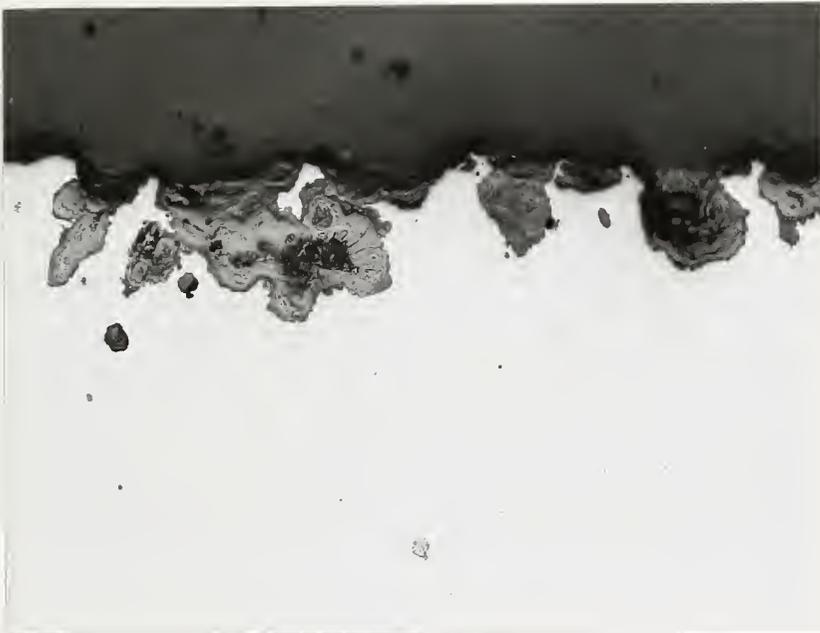
An unetched microstructure of a cross section taken through a used chain link and intersecting the surface of the link is shown in figure 21. There appears to be some corrosion or scale that has penetrated the surface. A few inclusions can be seen, but the material appears to be relatively clean.

Figure 21. Unetched microstructure of cross section through used chain link. Cross section intersects the link outside surface about 2/3 from the bottom of the photomicrograph. There is some corrosion product or scale (grey) at the surface. There are a few inclusions (dark) in the material (white). X 100

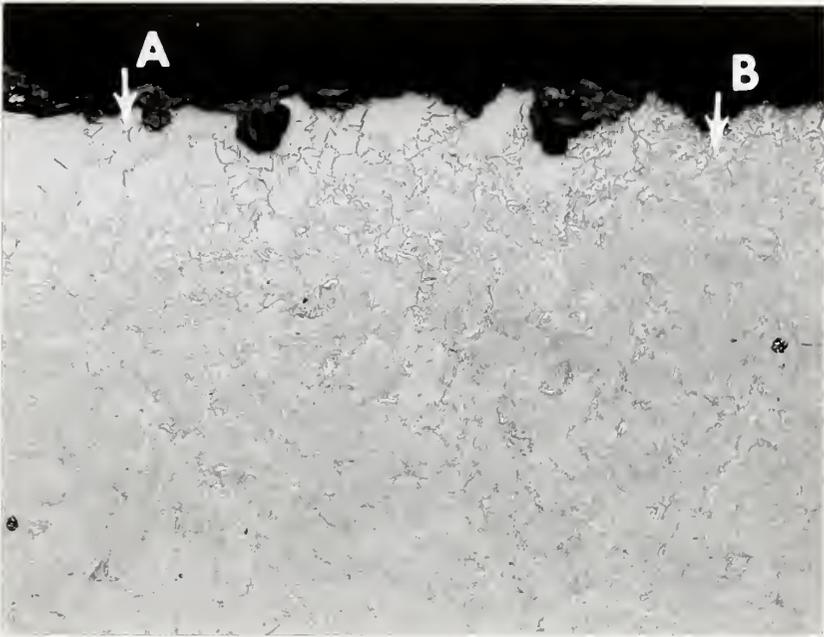
An etched microstructure of a cross section intersecting the surface of the link is shown in figure 22. The microstructure consists primarily of very fine needles of tempered martensite. Near the surface, however, there are areas which appear to have been decarburized. A typical area of decarburization is indicated by arrow A. The phase appearing white in the photomicrograph is ferrite. The depth of the decarburized layer is not uniform. At the surface on the right of figure 22 (arrow B), the microstructure is predominantly martensite. Some of the surface may have been removed by grinding after the links were fabricated or heat treated, or by wear or corrosion in service.

Figure 22. Etched microstructure of cross section through used chain link. Cross section intersects outside surface of link near top of photomicrograph. Interior microstructure is primarily tempered martensite. Arrow A indicates region of severe decarburization (mostly ferrite) near surface. Arrow B indicates region of much less decarburization (mostly martensite). Etch: 3% nital. X 100

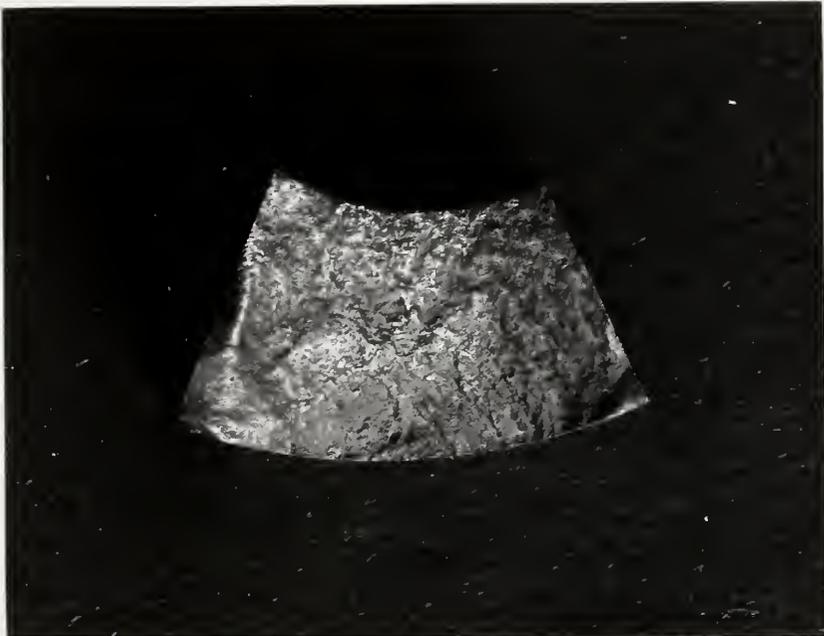
The fracture surfaces of the fractured trunnions were in poor condition for examination when submitted. They were corroded and showed evidence of mechanical damage. One of the better preserved fracture surfaces is shown in figure 23. The fracture surface has a rough, coarse-featured appearance. There was no evidence found to indicate fatigue or any other relatively slowly propagating crack mechanism contributing to the failure. Fracture was likely due to overload, perhaps caused (at least in part) by a stress concentration brought about by the bending of the softened trunnion pin.

The fracture surfaces of the failed trunnions were corroded and had suffered "damage" which obscured many of the fracture features. The apparent "damage" may have been mechanical in nature, but it may also have been produced by temperature excursions. Failure appears to have occurred due to overload. The trunnion-trunnion pin assembly still attached to the used grate was bent, as was the used pin which was not attached. If the trunnion pin bending is a common occurrence, stress concentrations could be imposed on the low ductility trunnion causing overload failure. High loads at about 1330° F during heating or cooling could have caused shear fracture with very little ductility in this material.

Figure 23. Fracture surface of one of the failed trunnions. X 2
